BMW model range 3 Touring (E91)

(2005->) First Registration: 22.04.2010

## sales reports

<b>customer:</b>	<b>BCA GmbH</b>
<b>report Number:</b>	<b>000000006850-EN98</b>
<b>contract number:</b>	.

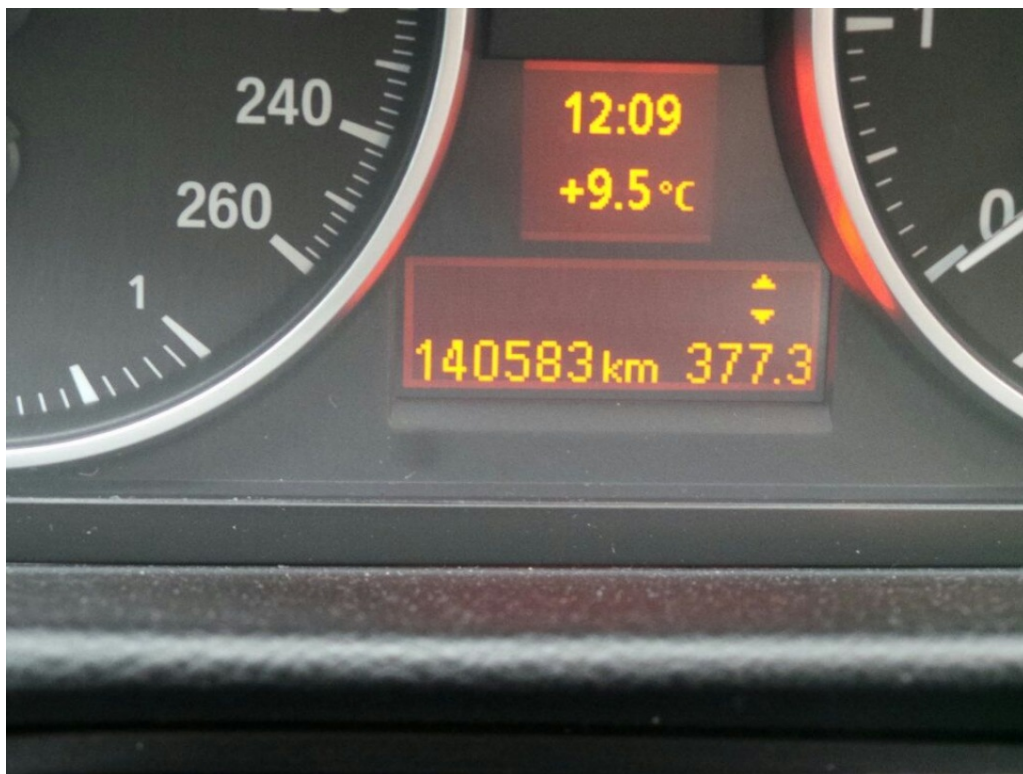
mileage

**Test for Mileagemanipulation successfully completed:**  yes

**Mileage manipulated:**  no

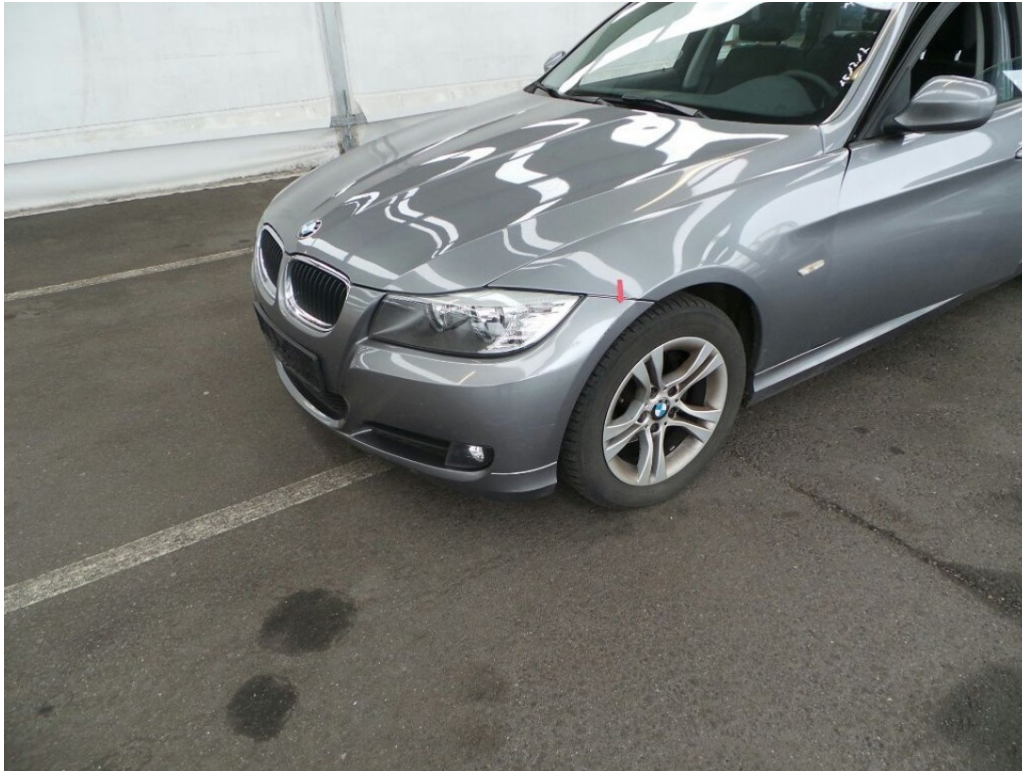
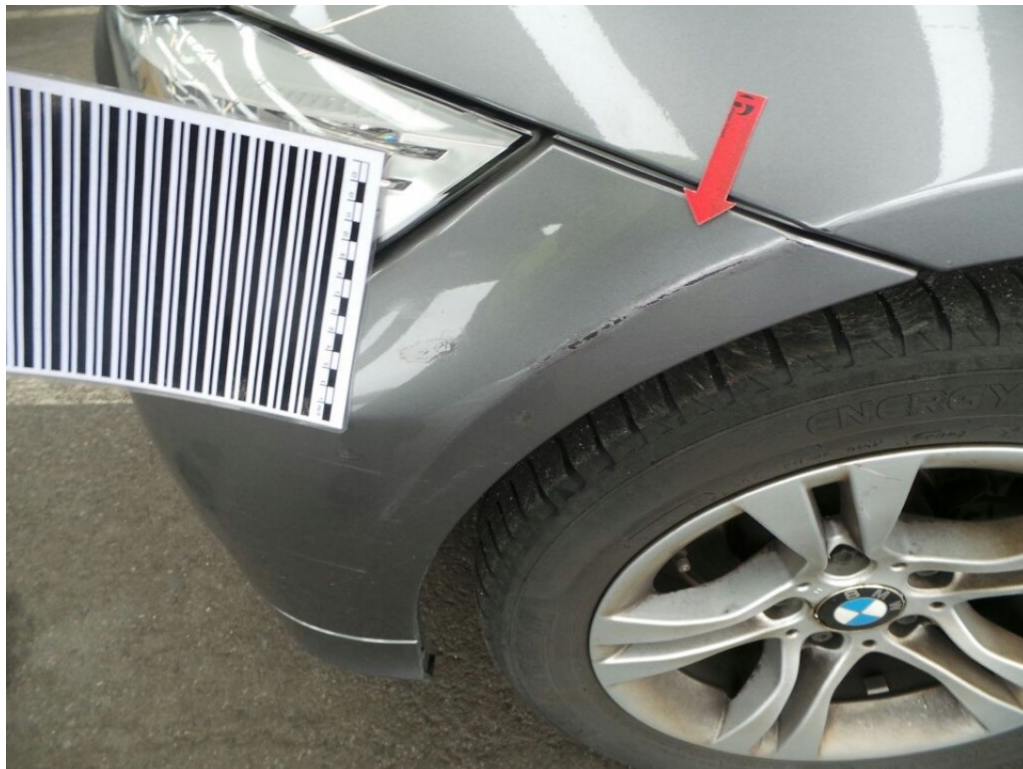
1.	Front bumper	Scratch(es)
----	--------------	-------------

Scratch(es)

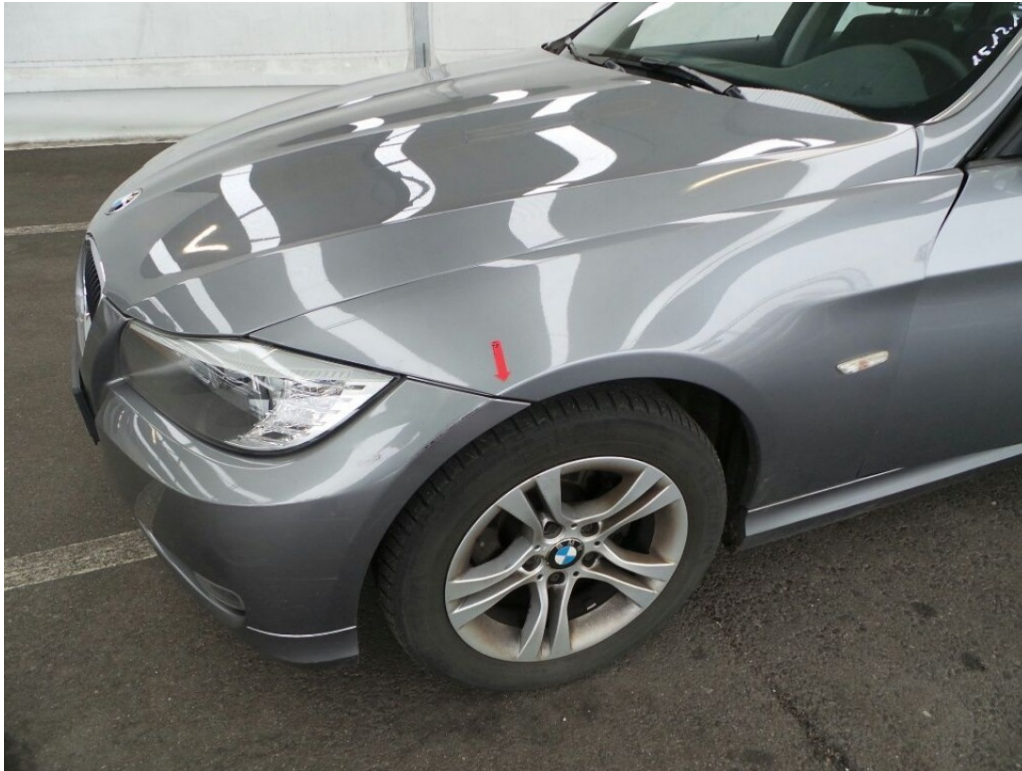
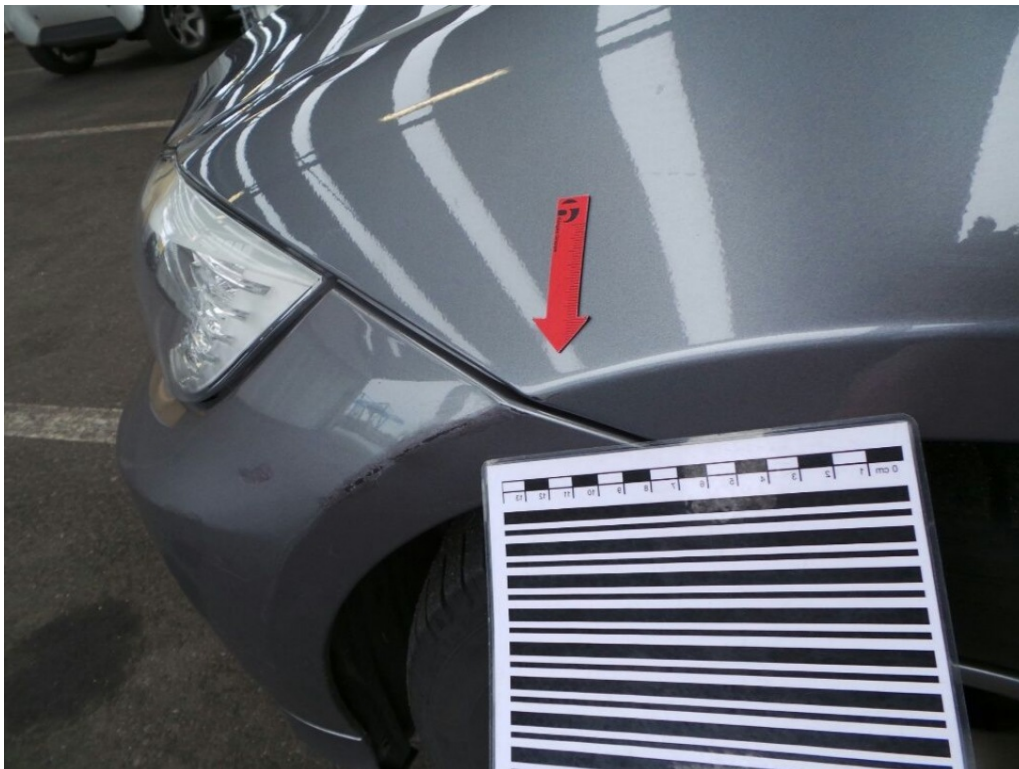
2. Front fender - left

| 2. | Front fender - left | Scratch(es) |

Scratch(es)

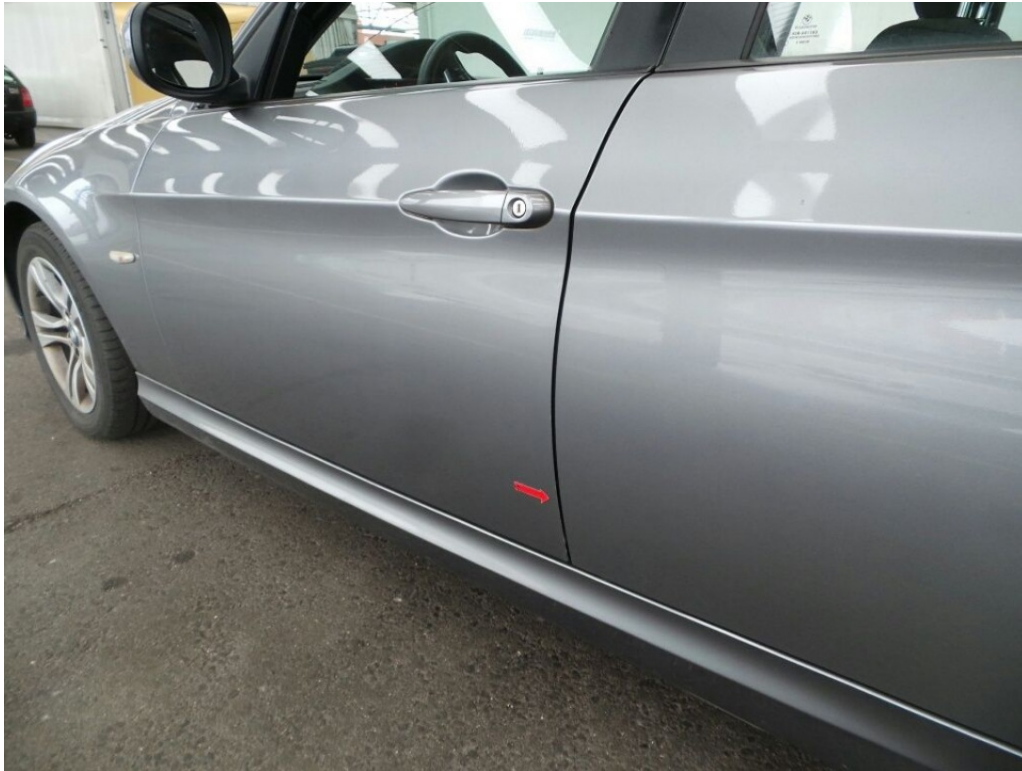
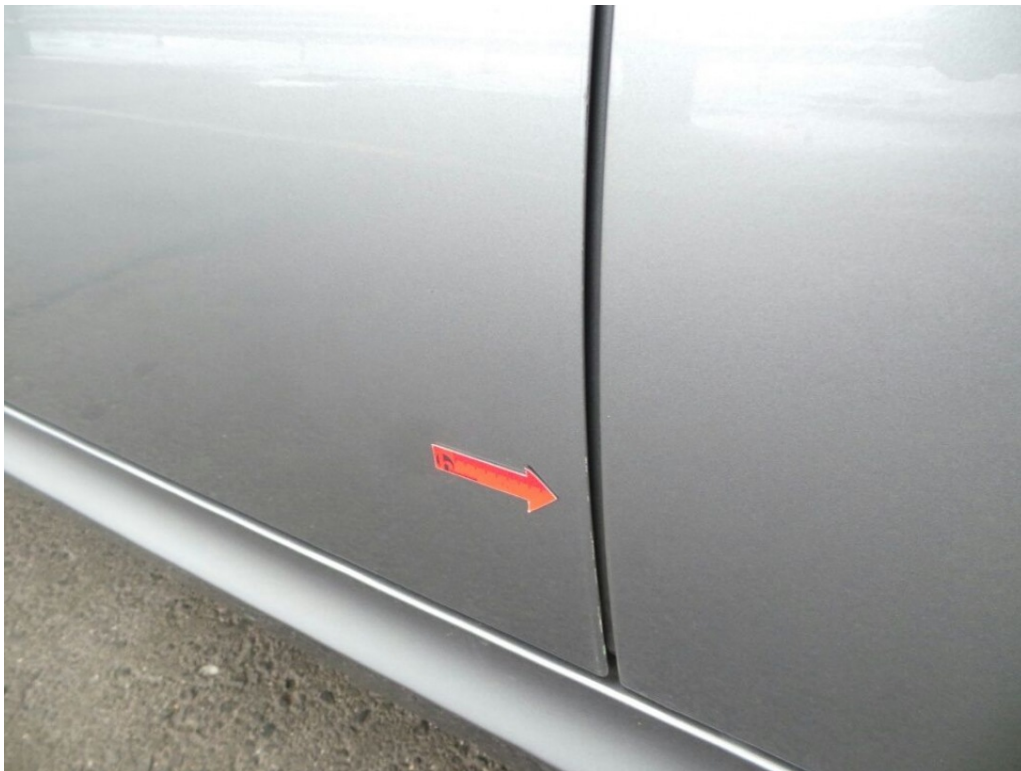
3. Front door - left

| 3. | Front door - left | Wear and tear |

**Wear and tear**

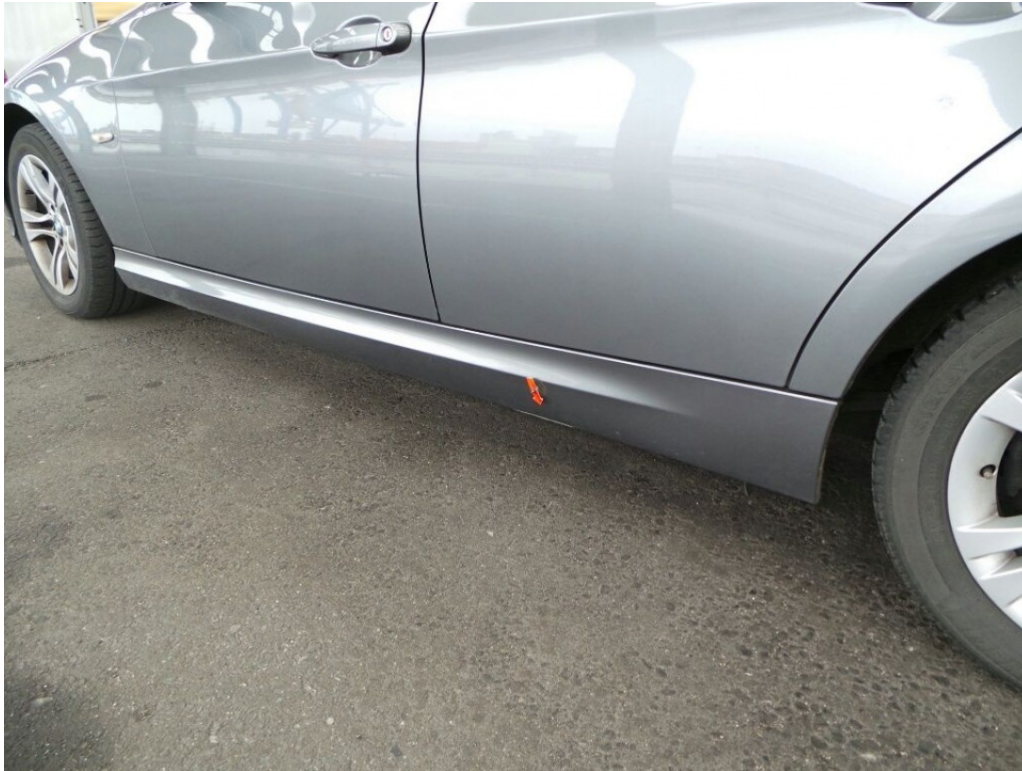
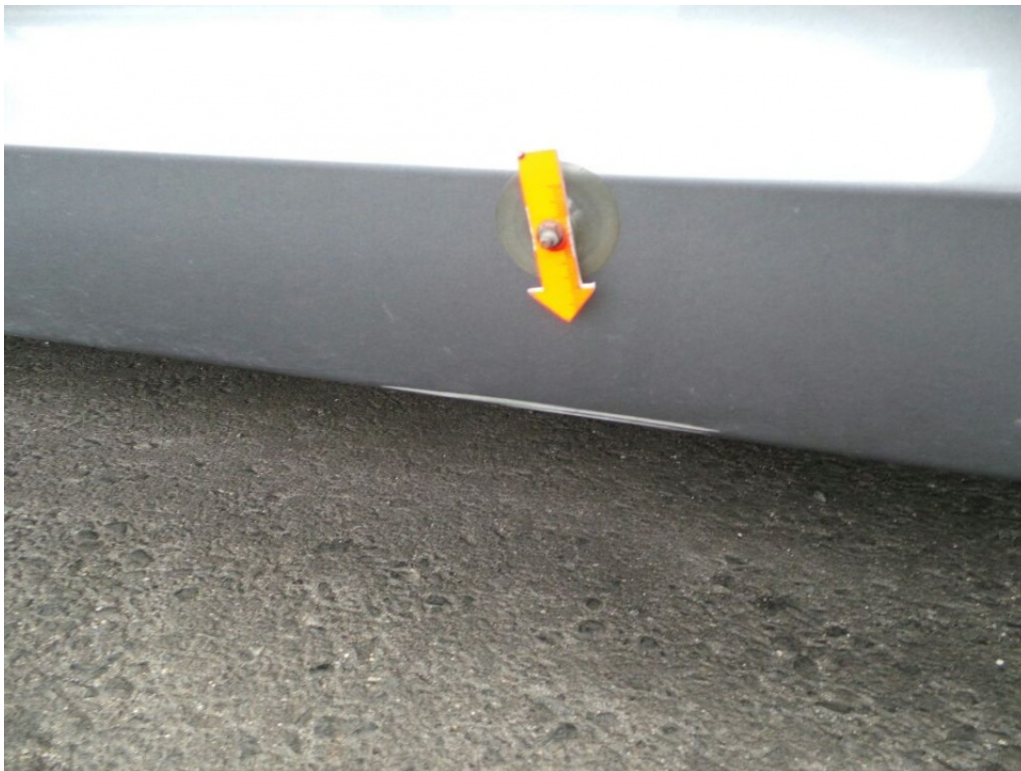
4. side skirt - left

| 4. | side skirt - left | Scratch(es) |

**Scratch(es)**

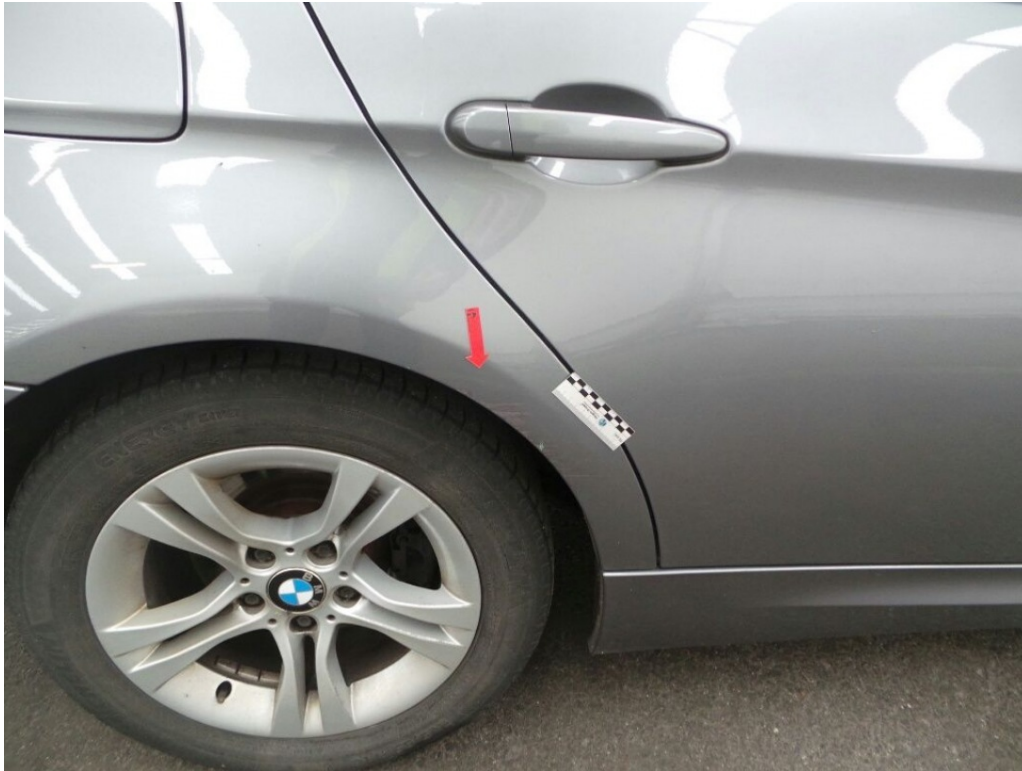
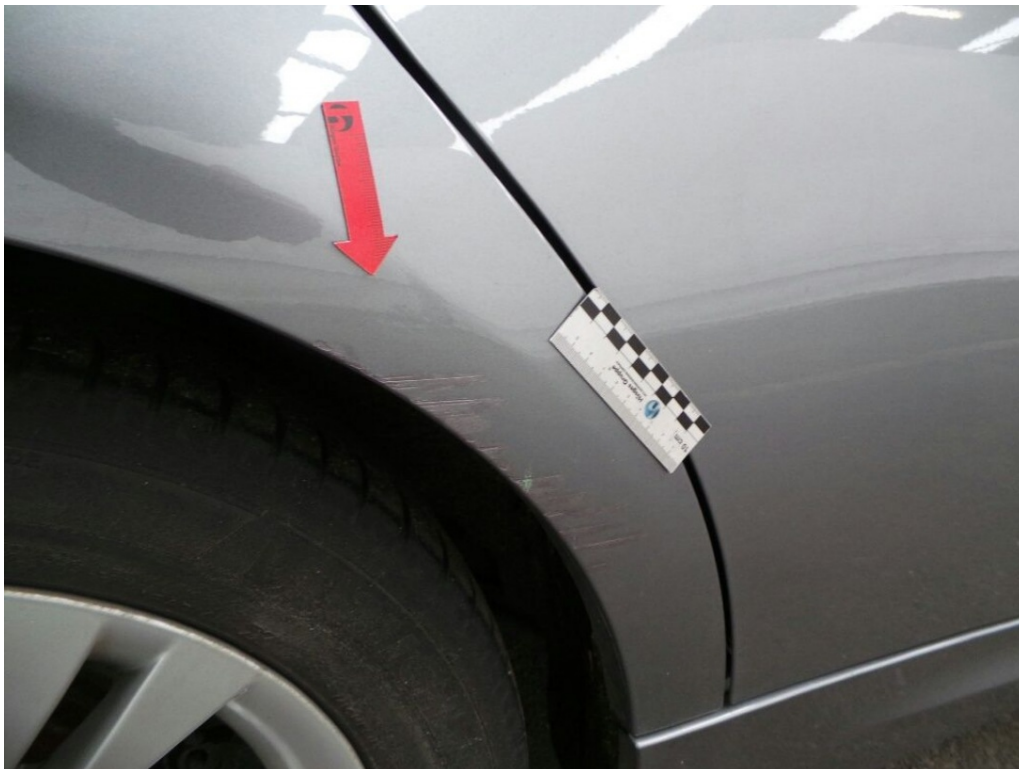
5. Sidewall - Rear - right

| 5. | Sidewall - Rear - right | Scratch(es) |

**Scratch(es)**

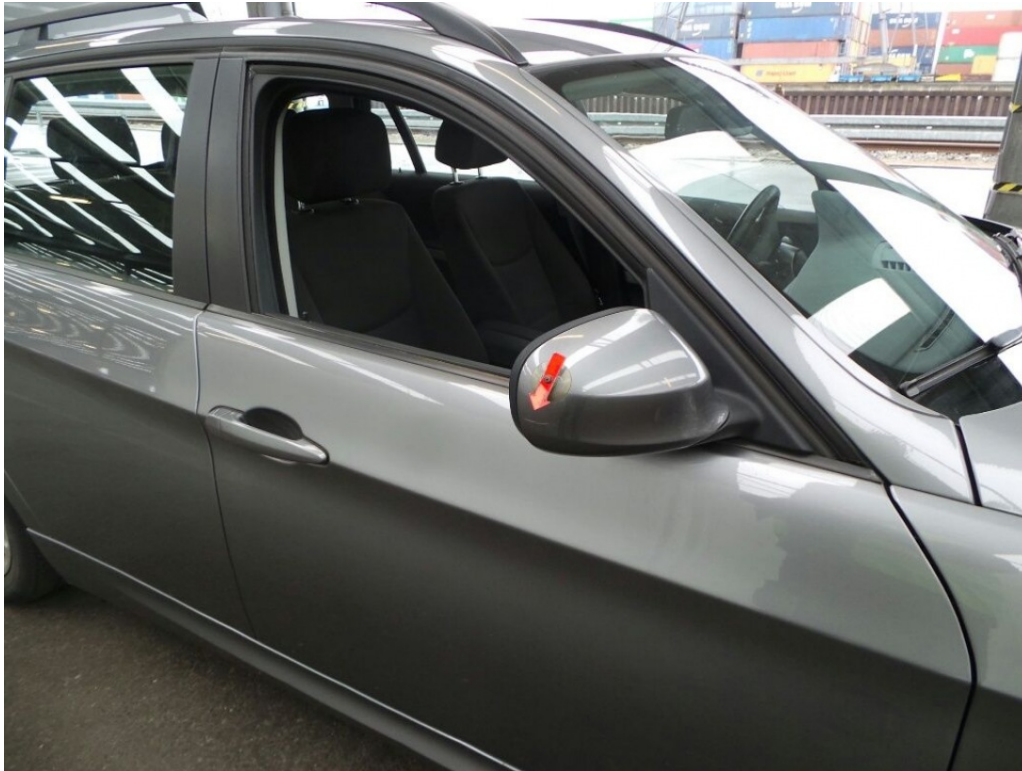
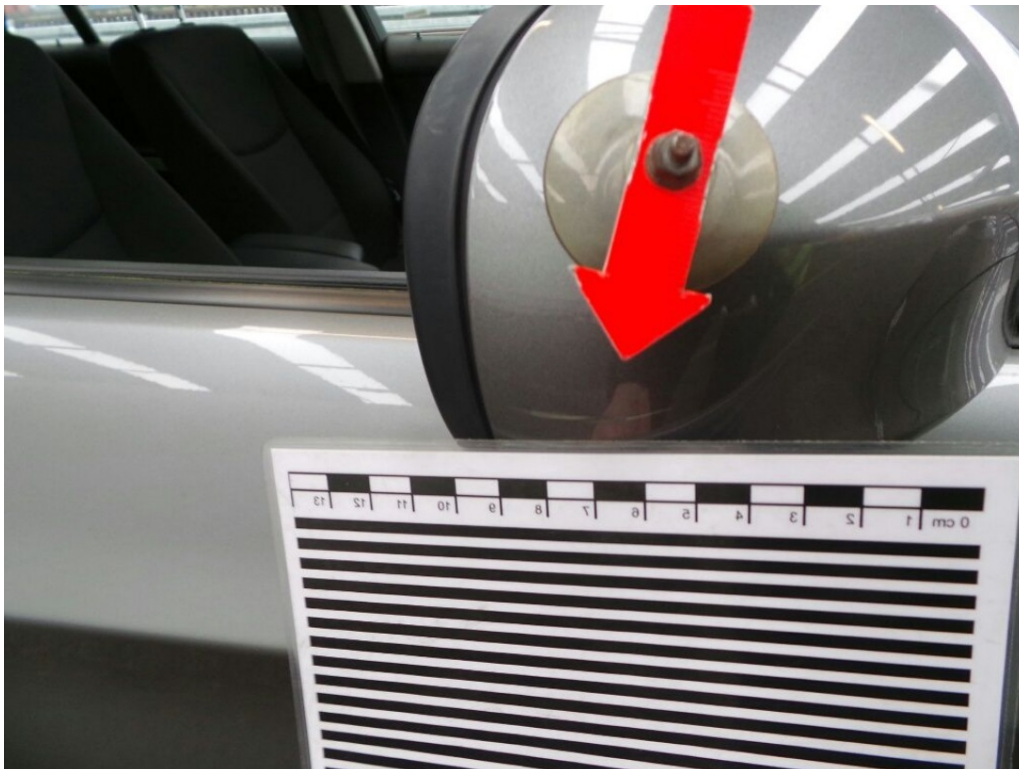
6. exterior rear view mirror shell - right

| 6. | exterior rear view mirror shell - right | Scratch(es) |

**Scratch(es)**

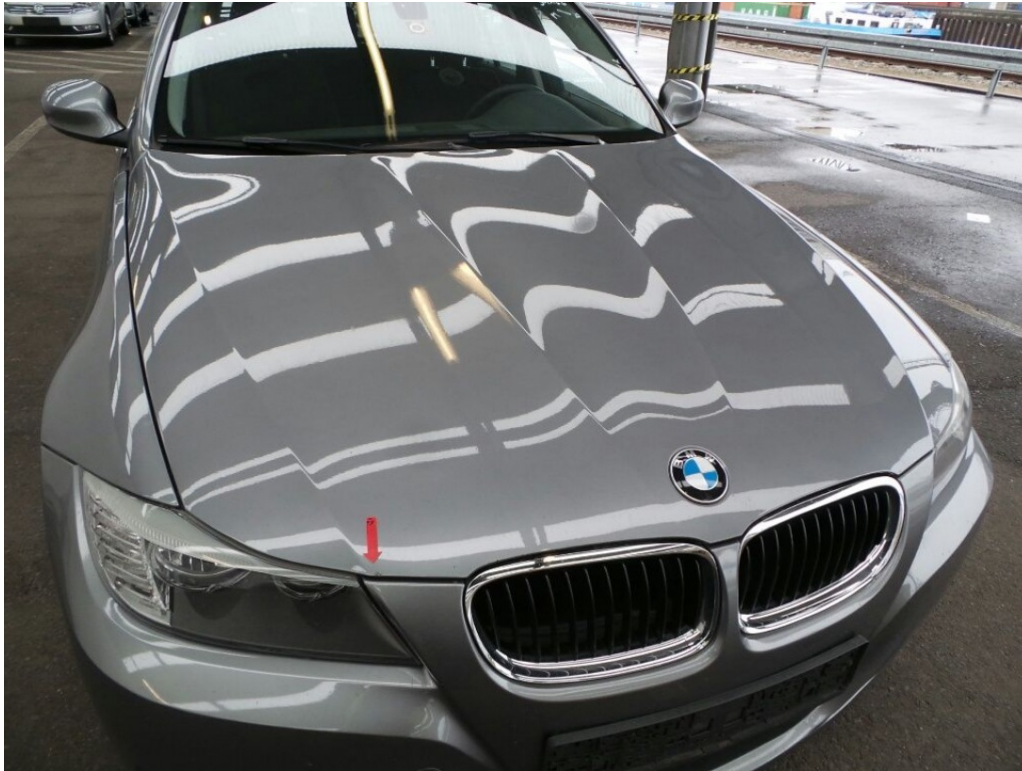
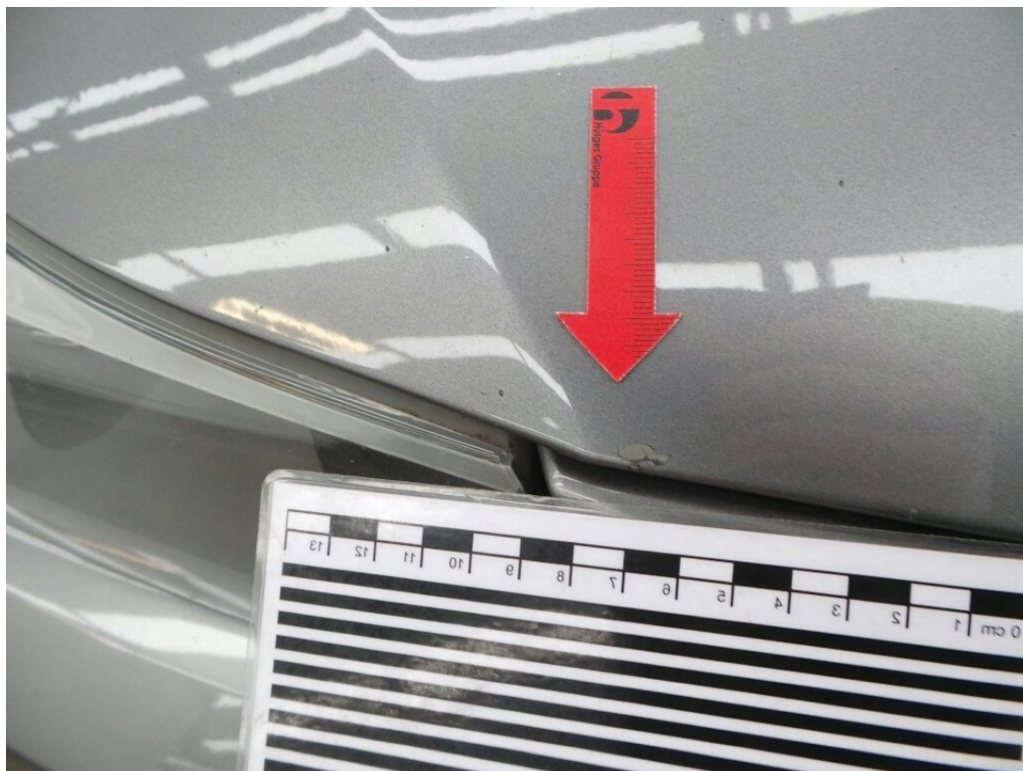
7. hood

| 7. | hood | Chipping from stones |

Chipping from stones
