Valuation reports

customer:	BCA GmbH	license plate:	TEST
report Number:	000000006850-EN99		
contract number:	.

vehicle data			
BMW model range 3 Touring (E91) (2005->) 318i			
Vehicle identification number	WBAUS31090A531166	mileage read:	140583 km
First Registration / construction year:	22.04.2010 / 2010	Visit Date / place of birth:	04.01.2018 Neuss
Bodywork:	cars	Re - import:	unknown
Body type:	hatchback	KBA no. :	0005//ALK
Fuel / emission class:	gasoline / -	transmission type:	6 speed manual transmission
GPS sat nav disk:	-	Displacement / power:	1995 ccm / 105 kW (143 PS)
Engine:	rear-wheel drive	paint:	SPACEGRAU METALLIC
Number of previous owners:	2	Doors / seats:	5 / 5
number keys:	2	Next HU / AU:	- / -
cushion type:	substance	Service book available:	no
Interior Color:	black	smoking vehicle:	no
Last service km / on the:	- / -	Vehicle roadworthy:	yes
Vehicle roadworthy:	yes	Submitted vehicle documents:	-
visit condition:	-	state general:	3 - Average

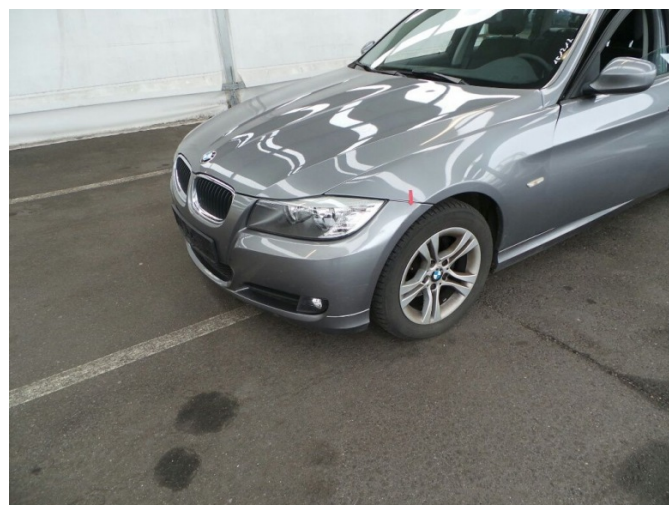
1. Front bumper
Scratch(es) - Refurbish and paint 0,00 € / 0,00 €

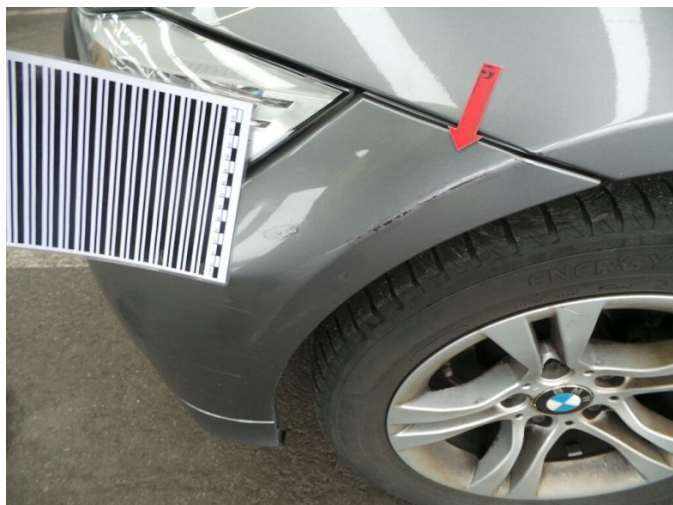
1. Front bumper
Scratch(es) - Refurbish and paint 0,00 € / 0,00 €

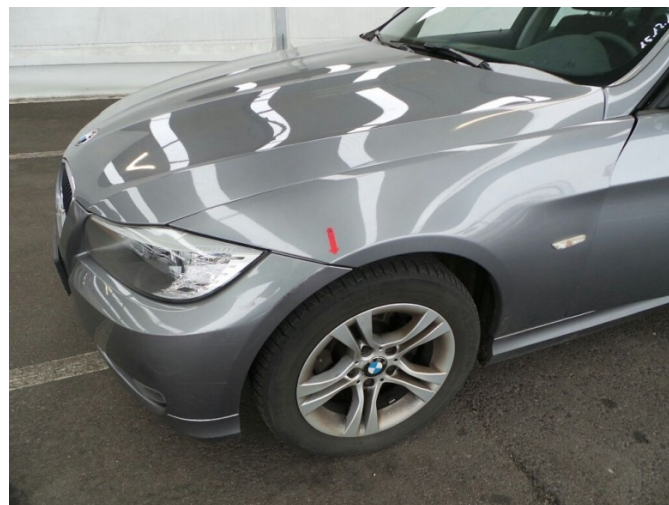
2. Front fender - left
Scratch(es) - Paint 316,00 € / 316,00 €

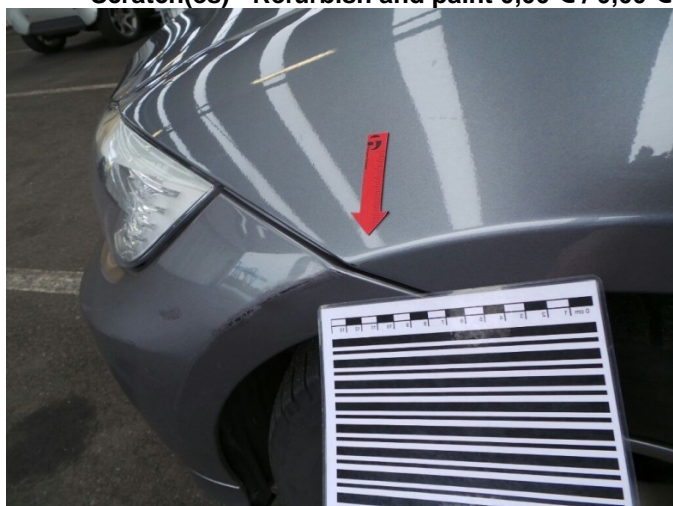
2. Front fender - left
Scratch(es) - Paint 316,00 € / 316,00 €

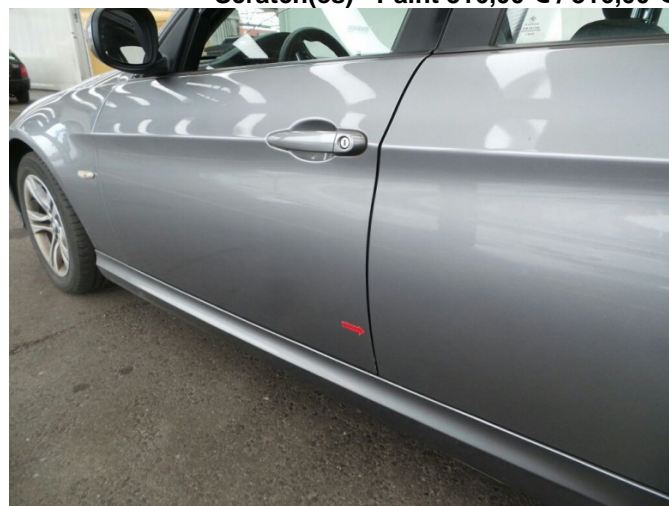
3. Front door - left
Wear and tear - Without repair 0,00 € / 0,00 €

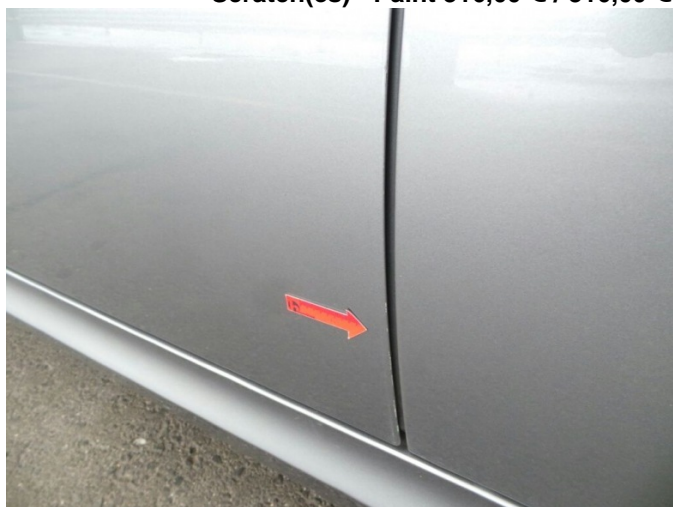
3. Front door - left
Wear and tear - Without repair 0,00 € / 0,00 €

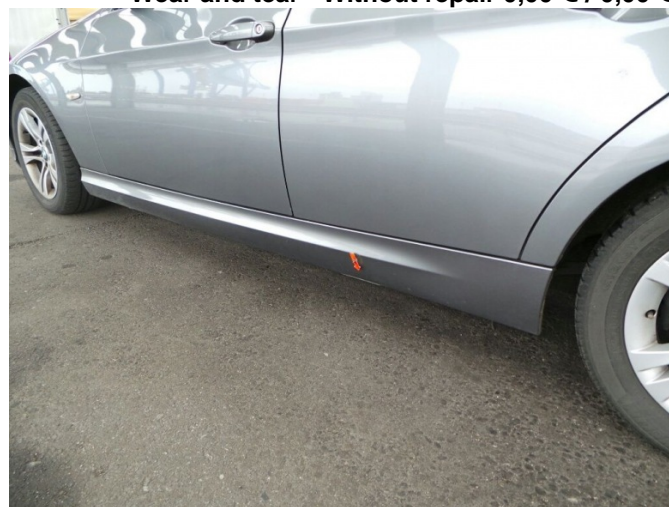
4. side skirt - left
Scratch(es) - Paint 0,00 € / 0,00 €

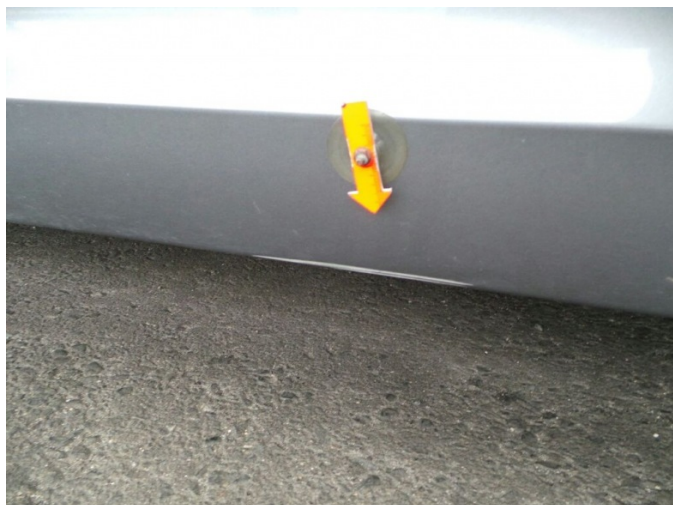
4. side skirt - left

Scratch(es) - Paint 0,00 € / 0,00 €

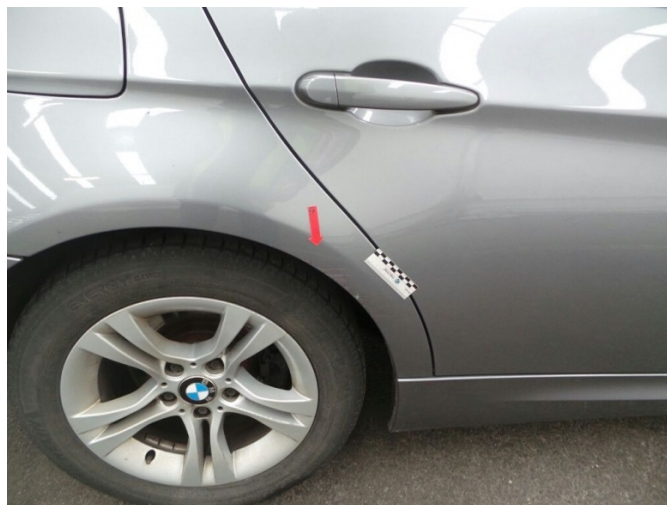
5. Sidewall - Rear - right

Scratch(es) - Paint 474,00 € / 94,80 €

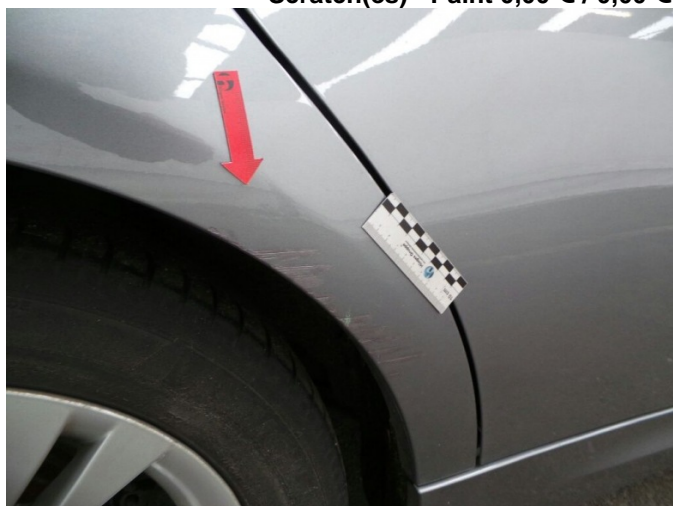
5. Sidewall - Rear - right

Scratch(es) - Paint 474,00 € / 94,80 €

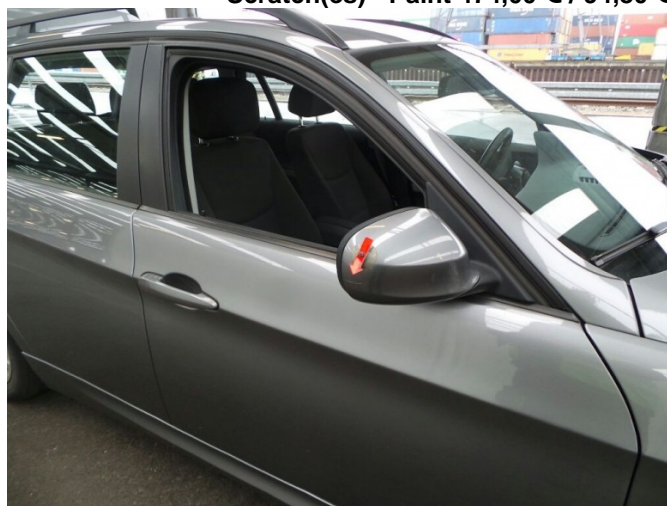
6. exterior rear view mirror shell - right

Scratch(es) - Smart repair 40,00 € / 40,00 €

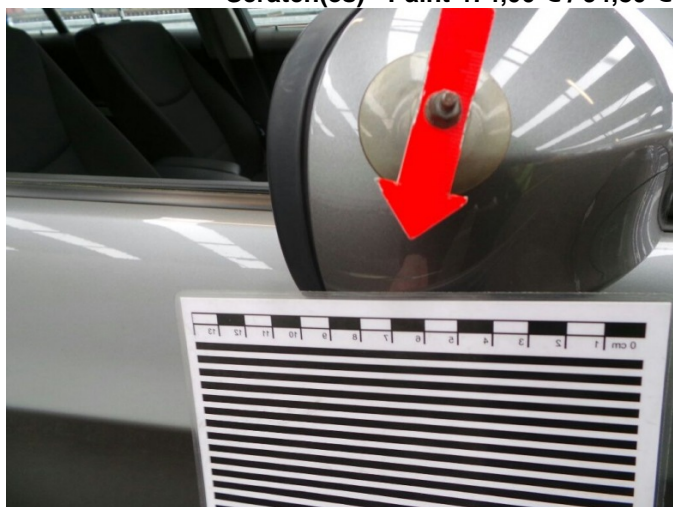
6. exterior rear view mirror shell - right

Scratch(es) - Smart repair 40,00 € / 40,00 €

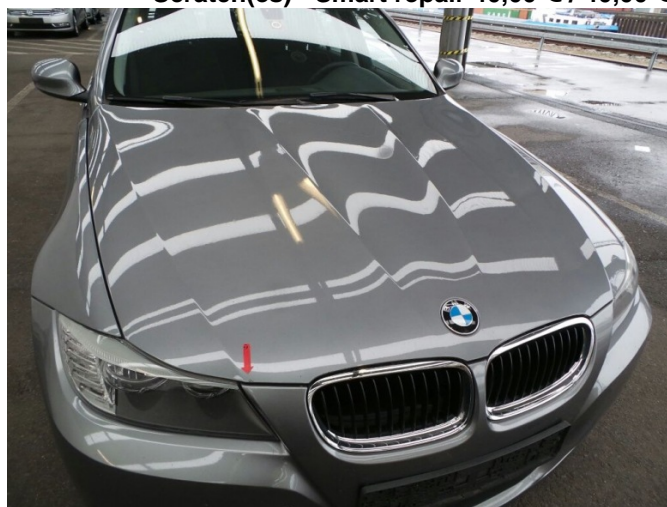
7. hood

Chipping from stones - Line/polish 100,00 € / 100,00 €

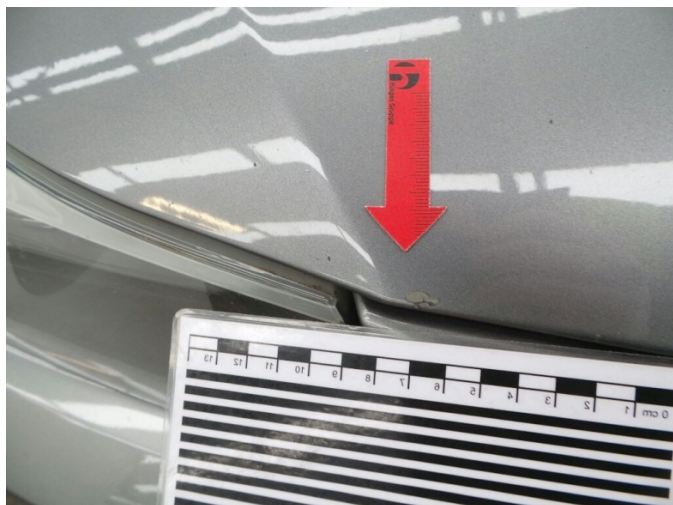
7. hood
Chipping from stones - Line/polish 100,00 € / 100,00 €
